UNIVERSITY OF DAR ES ALAAM  
DAR ES SALAAM UNIVERSITY COLLEGE OF EDUCATION

CONDITION SURVEY REPORT  
FOR  
CONSULTANCY SERVICES FOR COLLEGE BUILDINGS AND INFRASTRUCTURE  
TO BE REHABILITATED (REVIEW BILL OF QUANTITIES, ASSOCIATED DESIGN,  
DRAWINGS AND SUPERVISION OF REHABILITATION WORKS)

PREPARED AND SUBMITTED BY; Lead Consultant and Project Architects

**OGM CONSULTANTS**

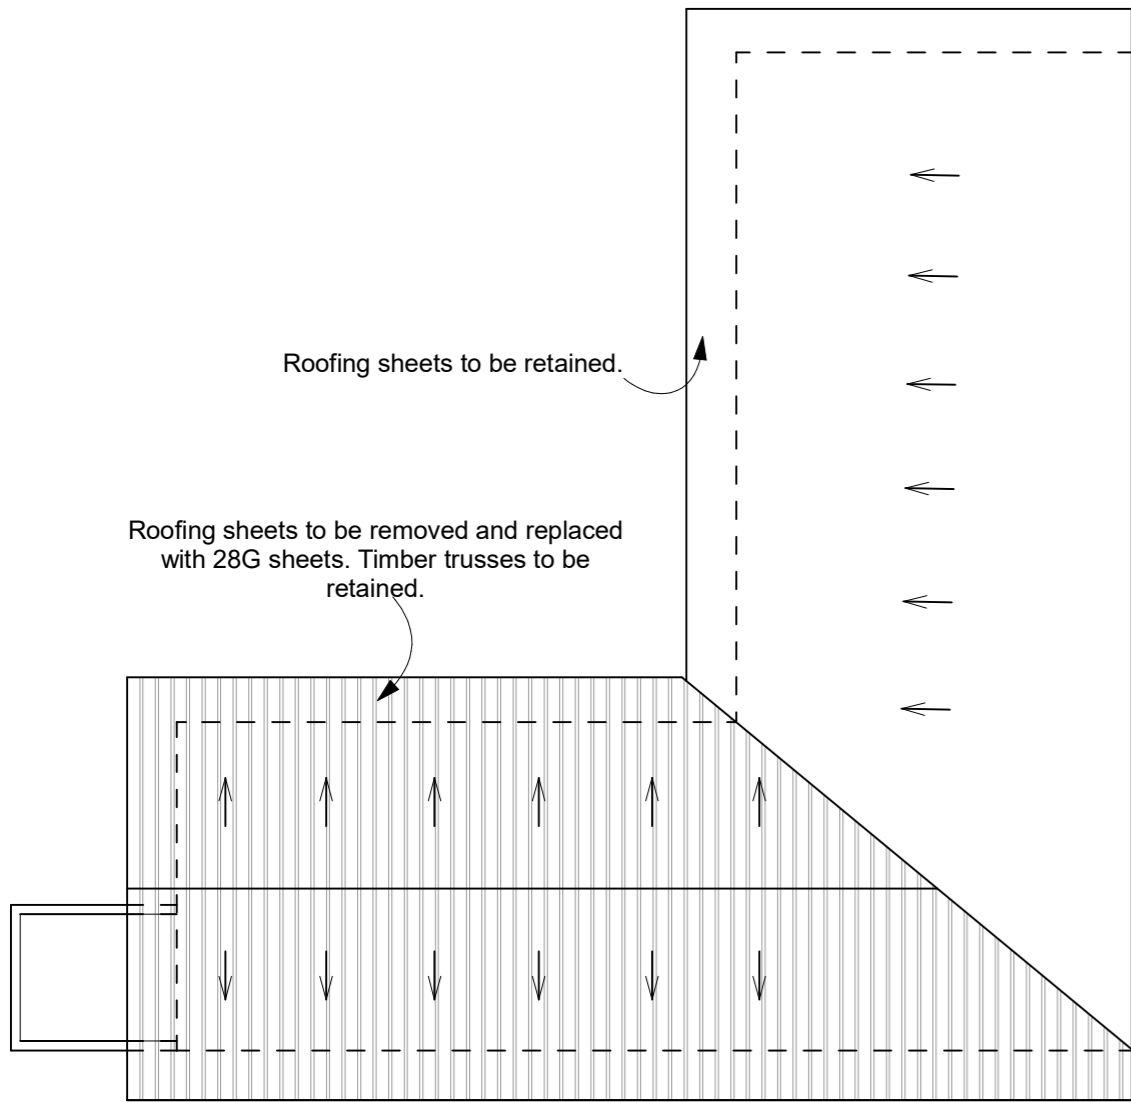
ROOF PLAN

1.1	<b>WORKS TO ROOFS</b> Remove existing roofing sheets to replace with 28Gauge Resin colour coated IT5 Aluminium sheets the new one.  <b>Quantity=100 sq.m</b>	For this building, only red colored roof sheets to be removed. The rest to remain. As Consultants, we recommend all roofing sheets to be IT 5 with 26 Gauge since it is more durable than 28 Gauge. <b>Quantity = As per drawing</b>

- 1: Roofing sheets to be removed and replaced with 28G sheets.
- 2: Roofing sheets to be retained.

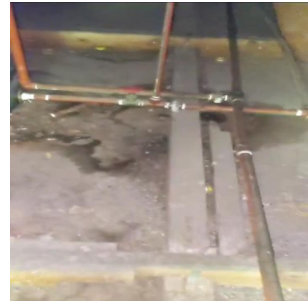
3.2	<b>PLUMBING, DRAINAGE AND ENGINEERING INSTALLATIONS.</b> Upgrade existing plumbing system of the whole building.  <b>Quantity = The whole Building</b>	The existing plumbing system of the whole building will be upgraded  <b>Quantity = The whole Building</b>

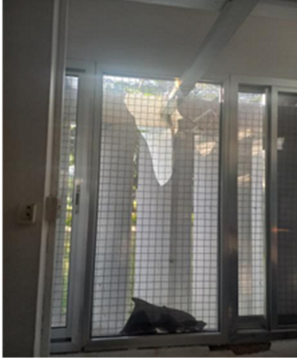
5.3	<p><b>CURTAINS</b> Supply and fix Curtains Complete set fabric and accessories to the following offices in the library building; Records room, Registry, special reserve room, Director office, Secretary office, Administrator office ICT and Publication.</p> <p><b>Items have been listed in B.O.Q</b></p>	<p>Curtains will be fixed in offices</p> <p><b>Items have been listed in B.O.Q</b></p>

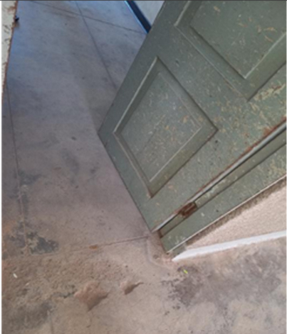
6.4	<p><b>UPPER WINDOW SEALING</b> Supply and fix white elamine board and Mninga/equivalent hardwood beads for</p>	<p>Mellamine board and Mninga/equivalent hardwood beads for upper windows and vent sealing works will be fixed.</p>

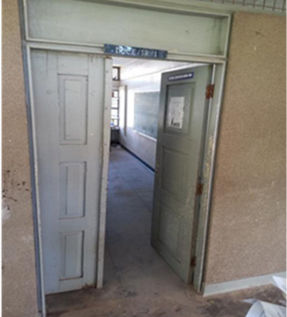
6.5	<p><b>FINISHINGS</b> Supply and fix new floor tiles</p> <p><b>Quantity=90 Sq.m.</b></p>	<p>600 x 600mm New floor tiles with R.A.K brand will be fixed</p> <p><b>Quantity= As per drawing</b></p>	
6.6	<p><b>AIR CONDITIONER INSTALLATION</b> Supply and fix air conditions in this room.</p> <p><b>Quantity= 2No.</b></p>	<p>Air conditions in this room will be fixed</p> <p><b>Quantity= As per drawing</b></p>

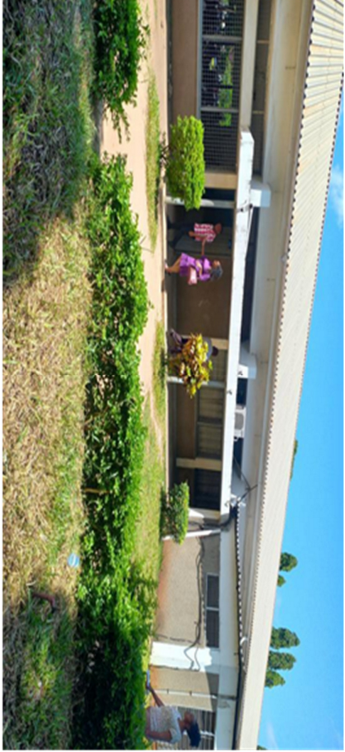
<b>VOLUME 2.7 - SCIENCE BLOCK</b>			
<b>S.No.</b>	<b>SCHEDULE OF REHABILITATION WORKS AS PER B.O.Q</b>	<b>CONSULTANT'S REVIEW AFTER A CONDITION SURVEY</b>	<b>PHOTOGRAPHS</b>
7.1	<b>ROOFING OF THE CONCRETE FLAT ROOF</b> Supply and fix roofing materials for roofing leaking concrete flat roof including painting materials on roof.  <b>Quantity=20 NR</b>	IT 5 roofing materials with 26 Gauge will be fixed  <b>Quantity = As per drawing</b>

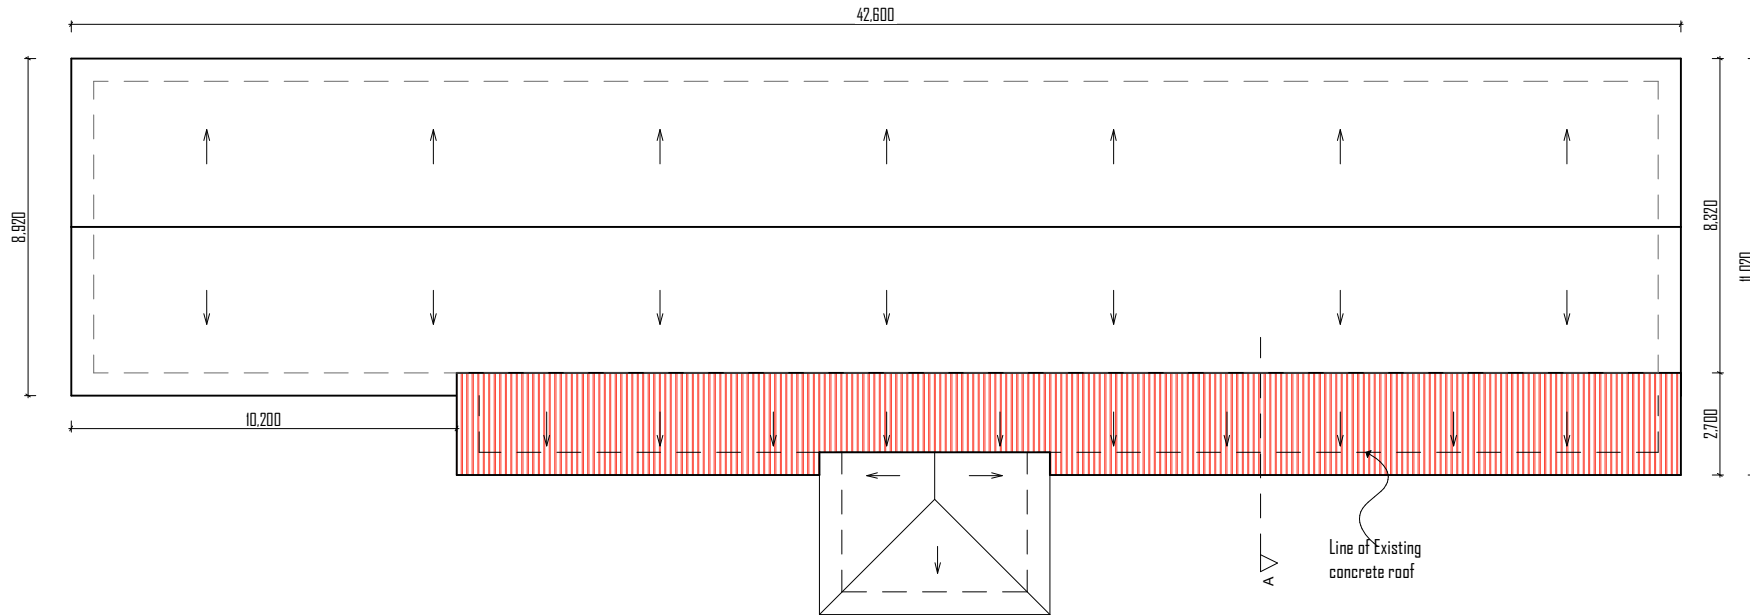
PROPOSED ROOF PLAN

8.1	<b>ROOF COVERING</b> Remove existing roofing sheets to steel trusses. Cover flat or sloping roof not exceeding 45 degrees from horizontal, fixed to Z-purlins with roofing screws and bituminous washers..  <b>Quantity= 1360 Sq.m.</b>	Existing roofing sheet will be removed and replaced with IT 5 with 26 gauge roofing sheet  <b>Quantity= As per drawing</b>

- 1: New Roofing sheets to be replaced with 26G IT5 covered.
- 2: Existing Roofing sheets to be retained.
