UNIVERSITY OF DAR ES ALAAM  
DAR ES SALAAM UNIVERSITY COLLEGE OF EDUCATION

CONDITION SURVEY REPORT  
FOR  
CONSULTANCY SERVICES FOR COLLEGE BUILDINGS AND INFRASTRUCTURE  
TO BE REHABILITATED (REVIEW BILL OF QUANTITIES, ASSOCIATED DESIGN,  
DRAWINGS AND SUPERVISION OF REHABILITATION WORKS)

PREPARED AND SUBMITTED BY; Lead Consultant and Project Architects

**OGM CONSULTANTS**

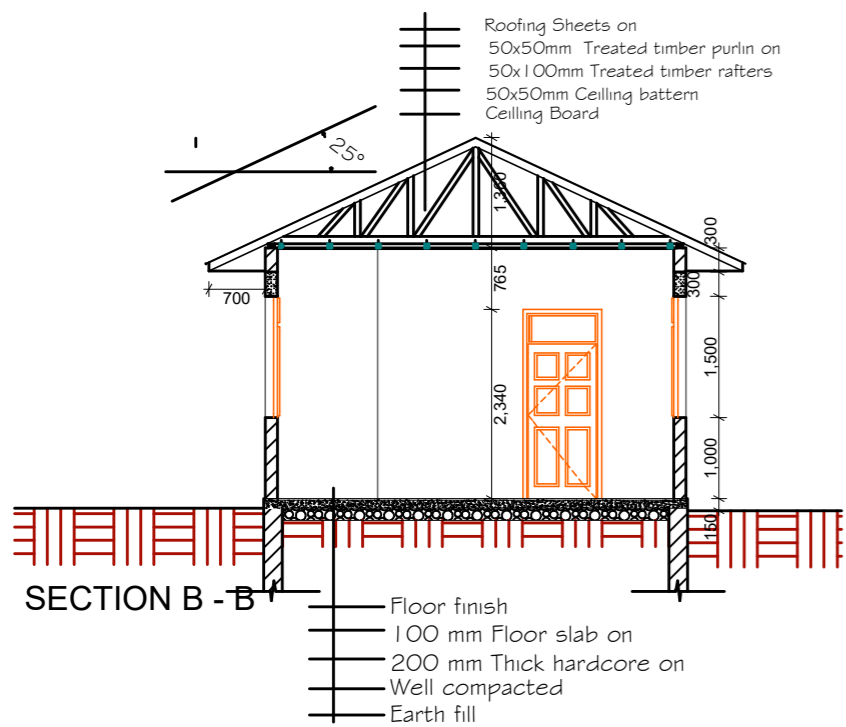
ROOF PLAN

- 1: Roofing sheets to be removed and replaced with 28G sheets.
- 2: Roofing sheets to be retained.

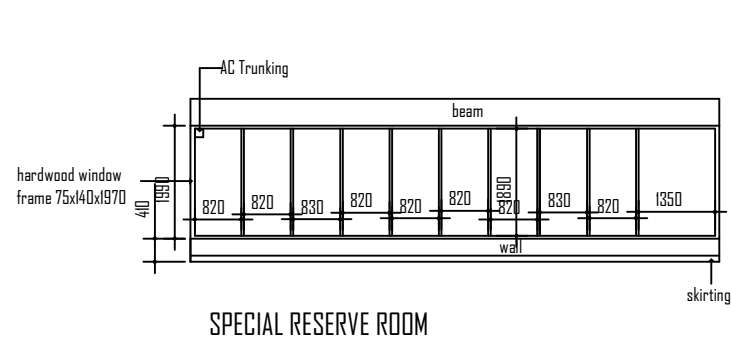
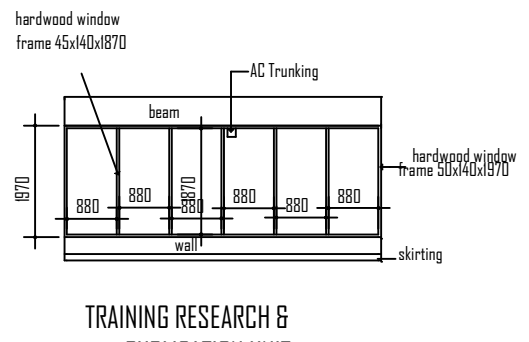
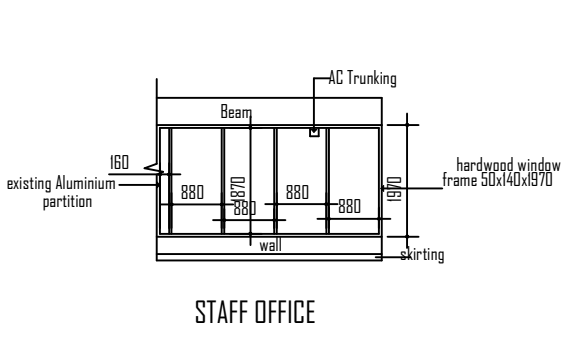
EXISTING WINDOWS

4.5	<p><b>ALUMINIUM WORKS</b> Carefully, dismantle; remove the louvers glasses windows and prepare the surface left behind including make good work disturbed. Supply and fix Aluminum (Sliding) windows. <b>Quantity= 6 Nos.</b></p>	<p>Louvered glass windows will be removed and replaced with Aluminium</p> <p><b>Quantity= As per drawing</b></p>

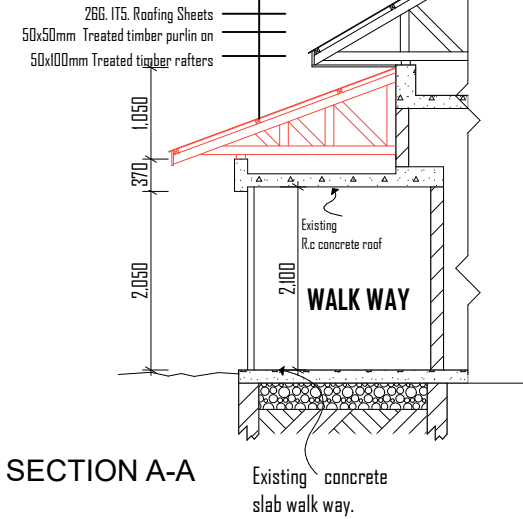
PROPOSED ROOF PLAN

8.1	<b>ROOF COVERING</b> Remove existing roofing sheets to steel trusses. Cover flat or sloping roof not exceeding 45 degrees from horizontal, fixed to Z-purlins with roofing screws and bituminous washers..  <b>Quantity= 1360 Sq.m.</b>	Existing roofing sheet will be removed and replaced with IT 5 with 26 gauge roofing sheet  <b>Quantity= As per drawing</b>

- 1: New Roofing sheets to be replaced with 26G IT5 covered.
- 2: Existing Roofing sheets to be retained.
